# Greater Shepparton City Council

## Katandra West Flood Scoping Study

### Final Report

May 2023

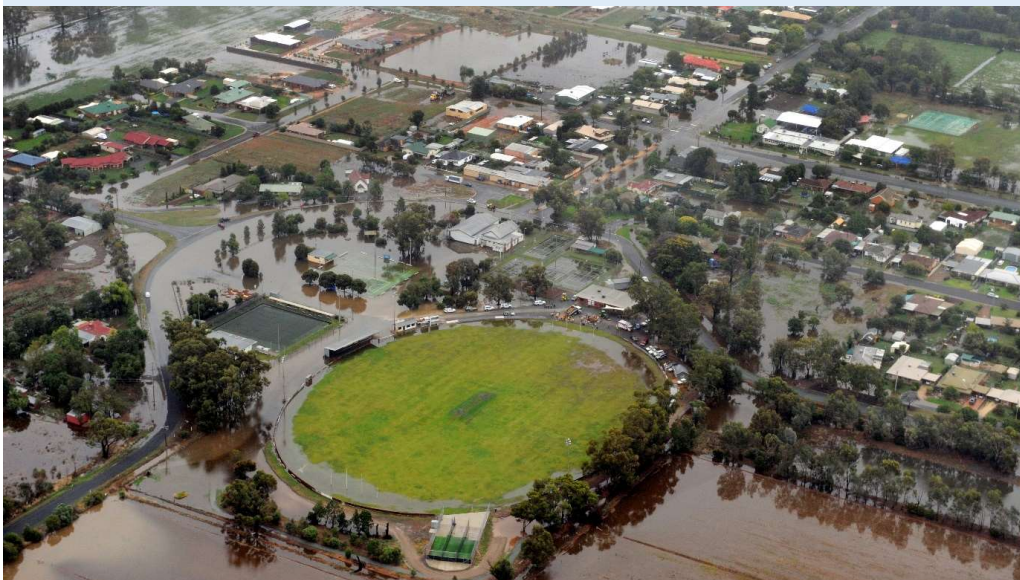
Cover photograph – March 2012 flood event – view looking north-west across Katandra West (photograph taken by Shepparton News at 1.18pm on Thursday 1 March 2012).

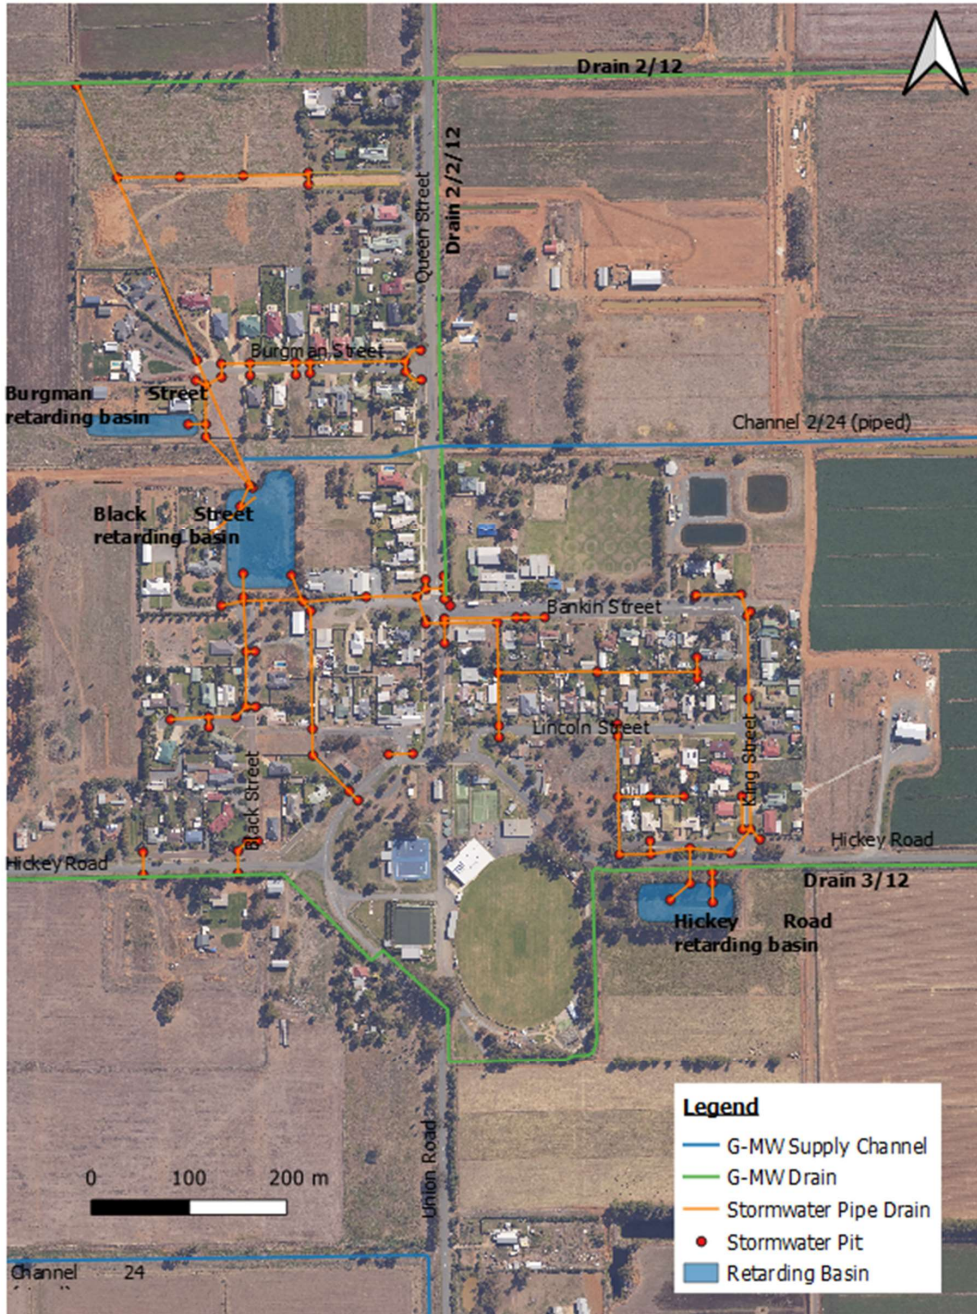
Figure 3 Stormwater Drainage & G-MW Drains at Katandra West

Pre 1990, G-MW drains were designed to drain over a period of 5 days the runoff from a rainfall event of 75 mm occurring within a 24 hour period. A 75 mm rainfall event in 24 hours is equivalent to approximately a 15 year average recurrence interval (ARI) Bureau of Meteorology (BOM) design rainfall event.

Current G-MW drain capacity design standards are for servicing runoff from a rainfall event of 50 mm over a 24 hour period. A 50 mm rainfall event in 24 hours is equivalent to approximately a 3 year ARI BOM design rainfall event.

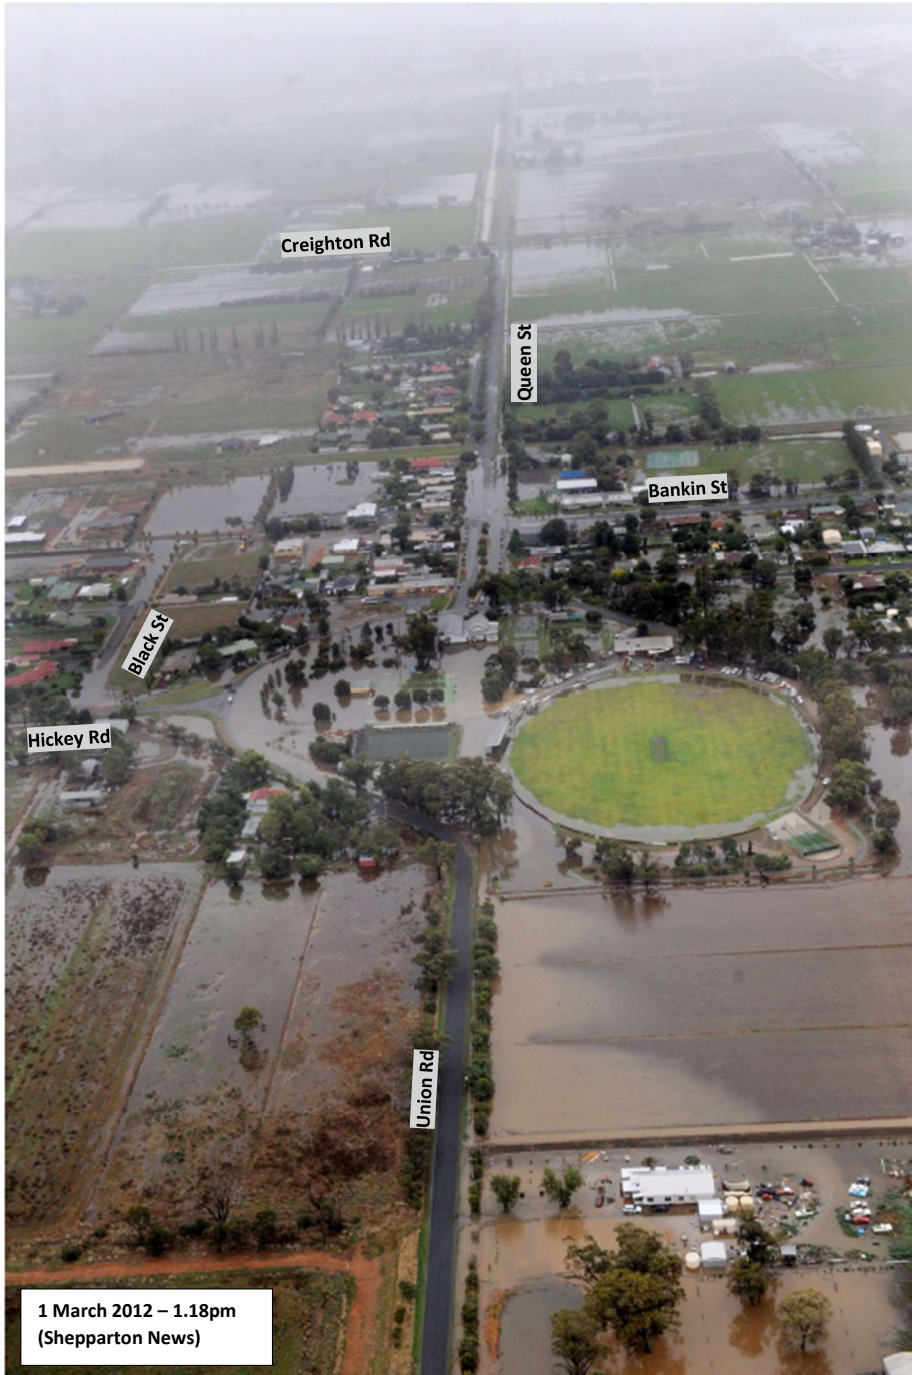
Figure 4 Aerial Photograph – March 2012 Flood

The SES also provided copies of aerial March 2012 flood photography originally obtained by Shepparton News. This includes the cover photograph of this report and the photograph shown in Figure 4.

An aerial photograph of the March 2012 flood (refer to Figure 4) shows this property to not be subject to inundation at the time the photograph was taken, which is thought to have been close to when peak flooding occurred.

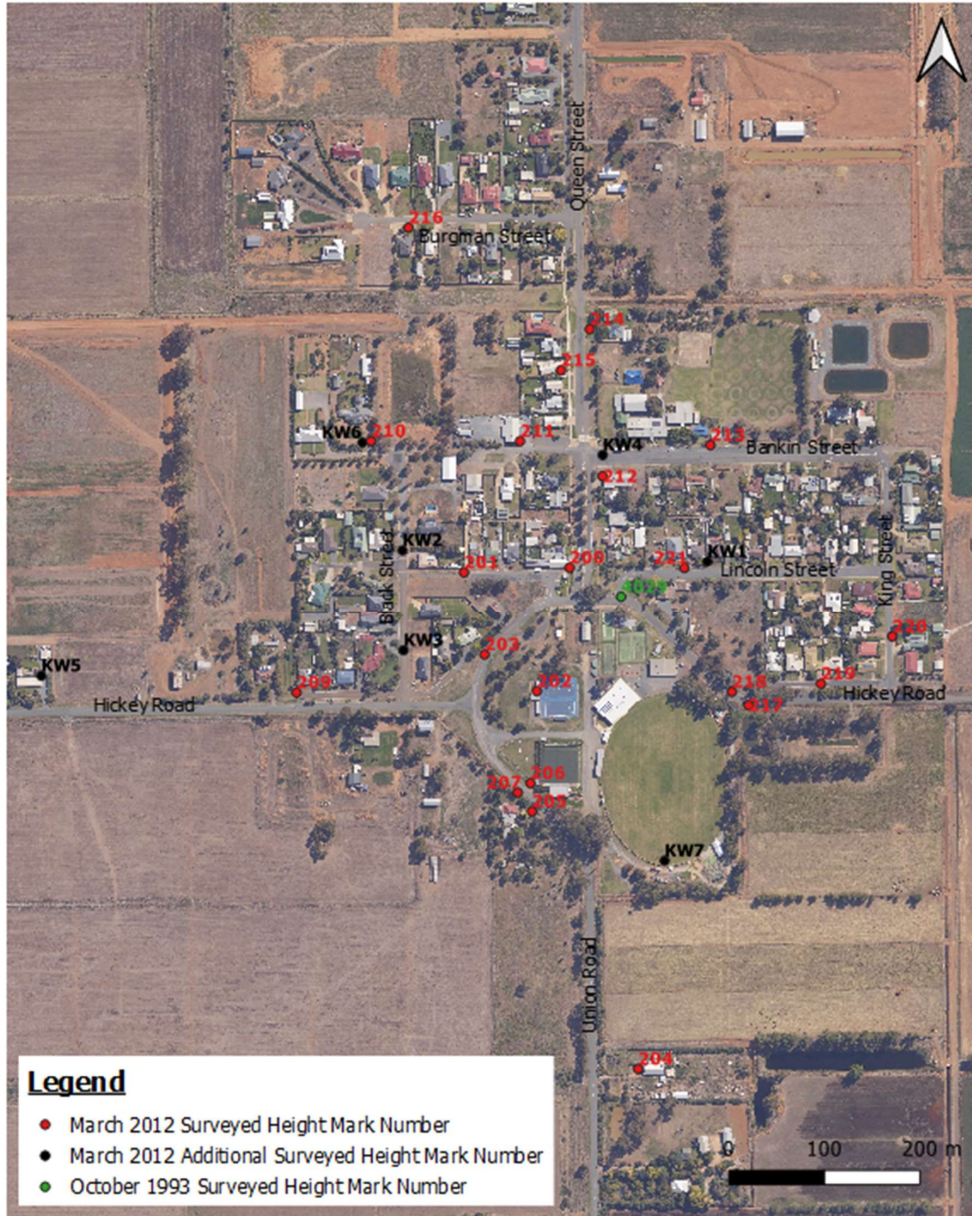
Figure 7 Surveyed Flood Height Marks

There is one 1993 spot flood height at Katandra West within the VFD (refer to Figure 7). Details are:

- Located at the intersection of Hickey Road and Lincoln Road (Mark 4029)
- Elevation 114.27 m AHD
- Assessed reliability – Low

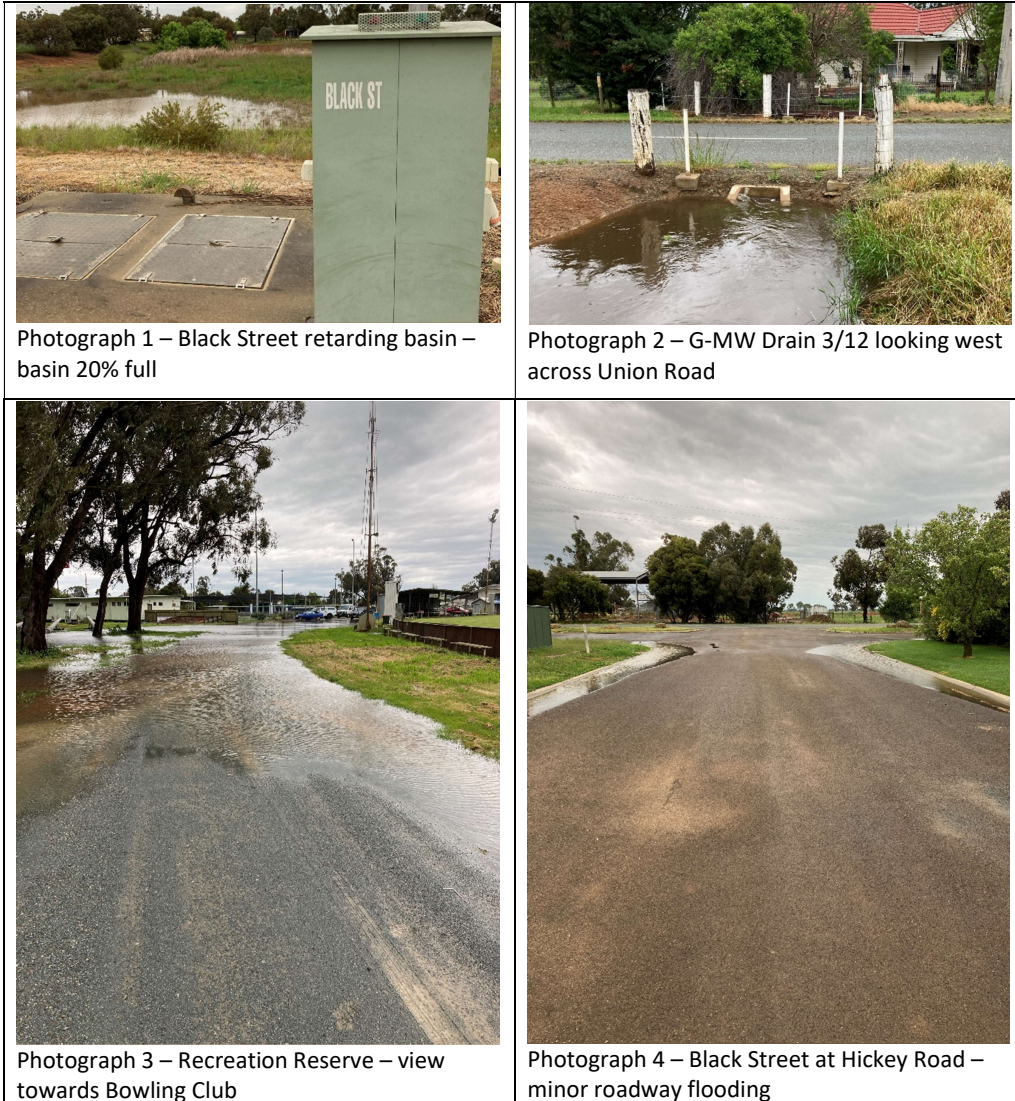
- Black Street retarding basin was at most 20% full (refer to Figure 9 - Photograph 1), Burgman Street basin was empty and the Hickey Road basin was less than a third full.
- The pumps at the Black Street and Hickey Road basins were both in operation.
- The intersection of Queen Street and Bankin Street was free of flooding.
- Flows in G-MW drains confined to in-bank. Drain 3/12 flowing close to full (refer to Figure 9, Photograph 2).
- A considerable amount of surface water was present at the south eastern corner of the Bowling Club (refer to Figure 9 – Photograph 3), covering the internal road and surrounds, but not impacting on any buildings.

Photograph 1 – Black Street retarding basin – basin 20% full

Photograph 2 – G-MW Drain 3/12 looking west across Union Road

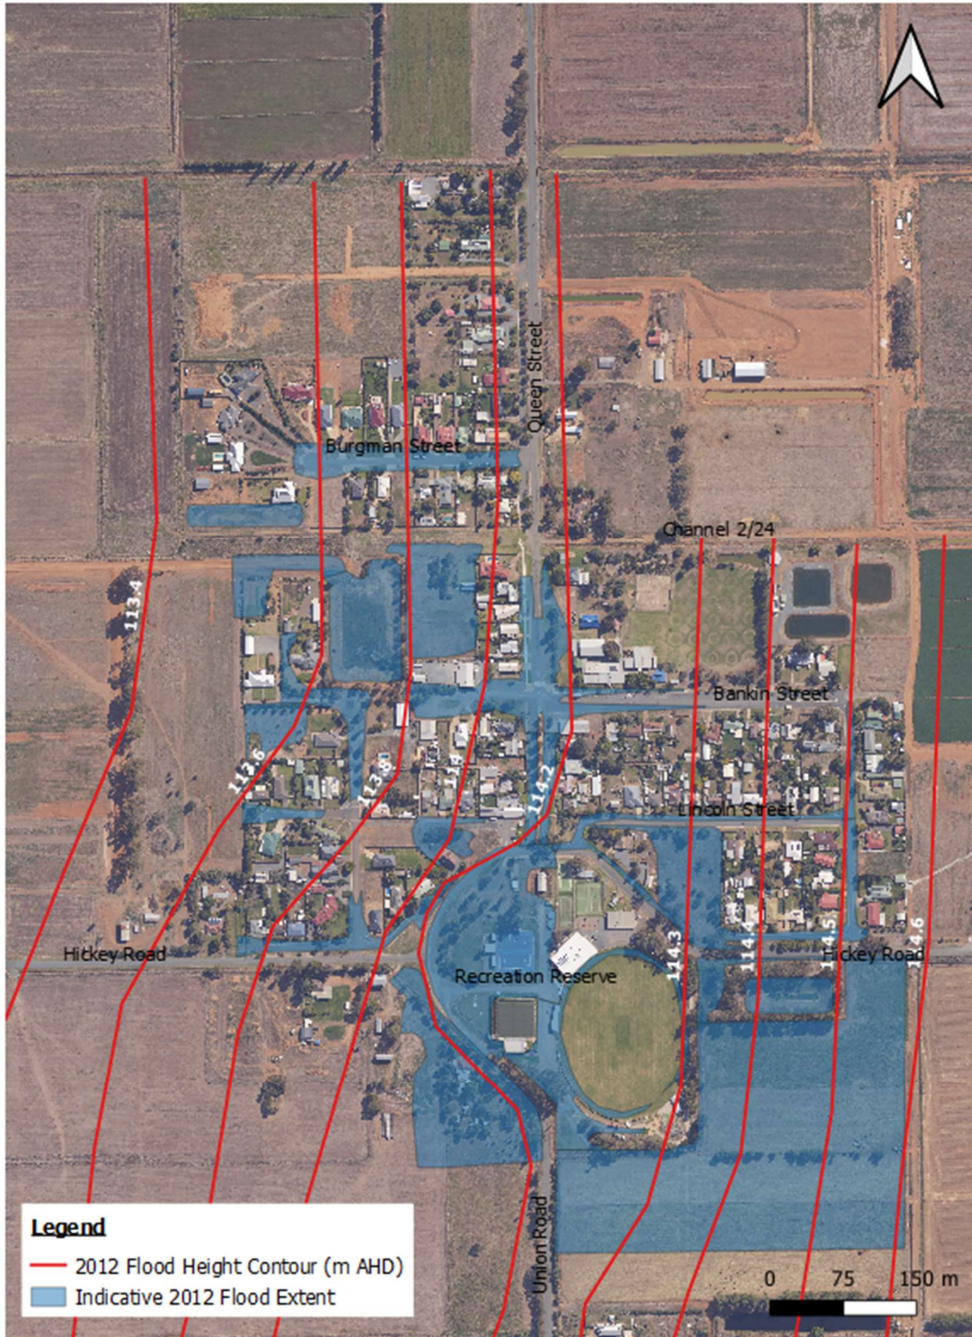
Figure 11 March 2012 Interpolated Flood Height Contours

Consequently a flood height contour of 114.3 m AHD has been adopted through the Recreation Reserve, reducing to 114.2 m AHD at Union Road / Hickey Road.

Impacts in this area in 2012 included above floor flooding of the netball pavilion (floor level of the pavilion is at ground level – approximately 114.05 m AHD). No other buildings are known to have been flooded to above floor level in this area.

Council and the Goulburn Broken CMA could consider adding the defined inundated areas shown on Figure 11 as new Land Subject to Inundation Overlay areas when the planning scheme overlays are next updated.

- Interpolated flood height contours within the township area. These are shown on Figure 11. The flood height contours are representative of 2012 flooding conditions which in turn are representative of indicative 1% AEP flooding conditions.
- Indicate flood extents within the township area. These are also shown on Figure 11. The extents are representative of 2012 flooding conditions.

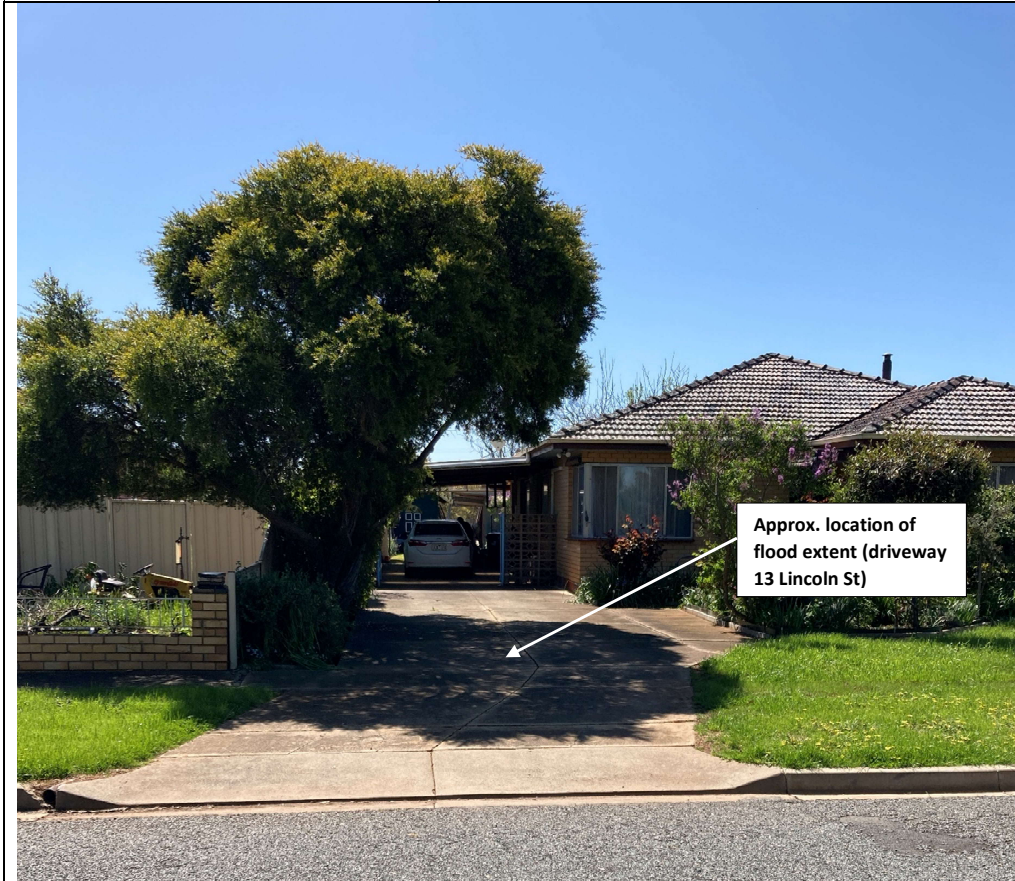
Flood Mark No.	FM2022-KW1
Date of interview / Inspection	29 September 2022
Name of Property Owner	Marjorie and Les Earl
Telephone	-
Address	13 Lincoln Street <a href="mailto:marjearl@bigpond.com">marjearl@bigpond.com</a>
Flood Description	Marjorie and Les Earl advised that floodwater did not encroach up their driveway beyond approximately their property boundary.
Reliability	Medium
Flood Level (m AHD)	114.23
MGA Zone 55 Coordinate - easting	370663
MGA Zone 55 Coordinate - northing	5989916

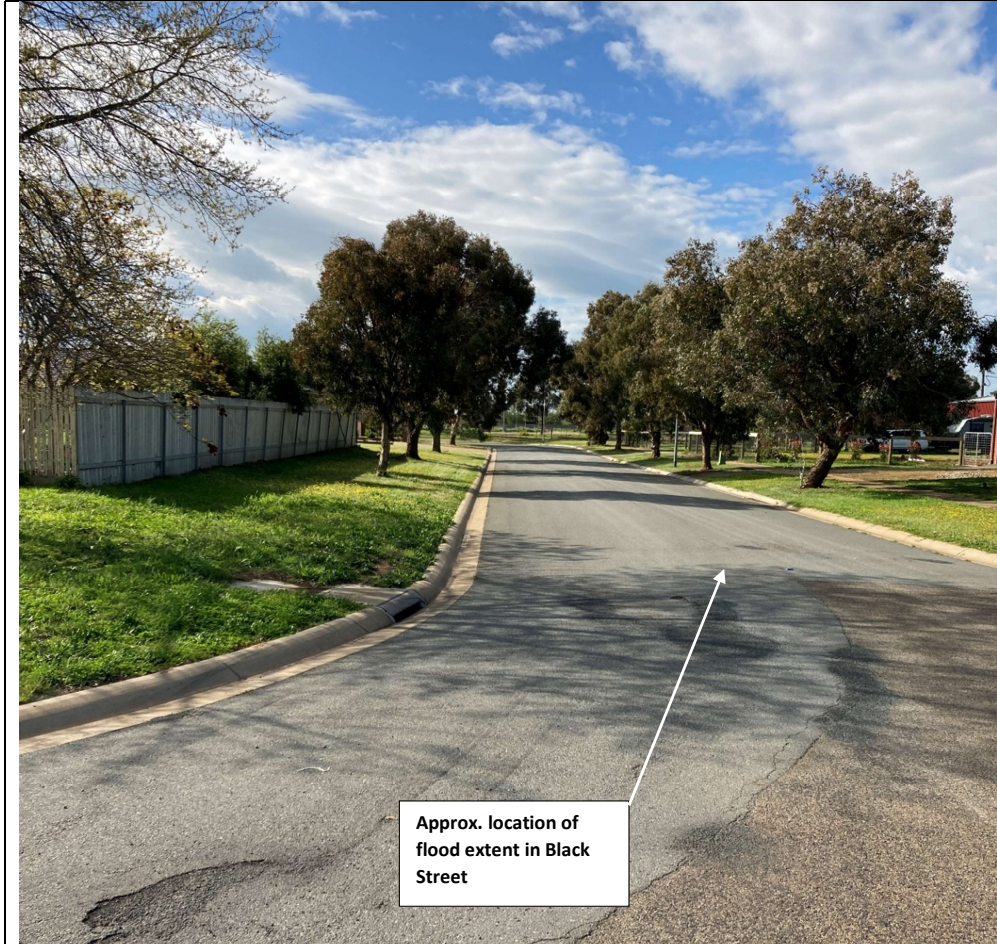
Flood Mark No.	FM2022-KW2
Date of interview / Inspection	28 September 2022
Name of Property Owner	Gary Warner
Telephone	-
Address	7 Black Street
Flood Description	Showed Gary the aerial photo taken at 1.20pm on 1.3.2012. He advised that this will have been close to peak. Location of mark at flood extent edge as per aerial photo.
Reliability	Medium
Flood Level (m AHD)	113.56
MGA Zone 55 Coordinate - easting	370344
MGA Zone 55 Coordinate - northing	5989938

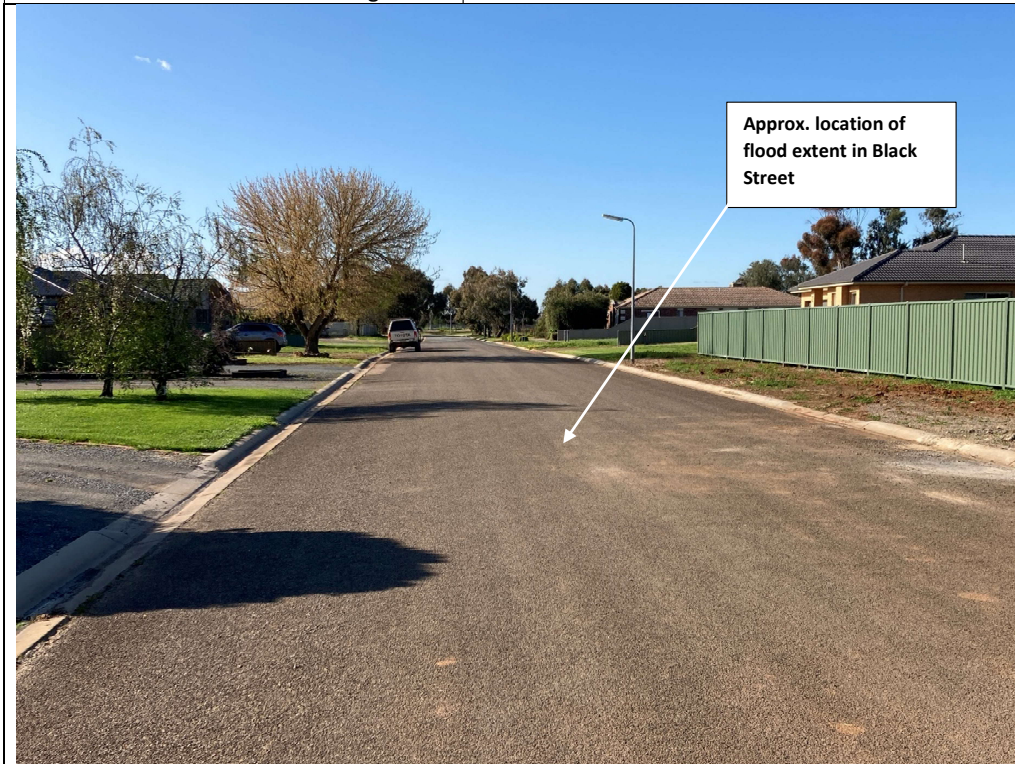
Flood Mark No.	FM 2022-KW3
Date of interview / Inspection	29 September 2022
Name of Property Owner	-
Telephone	-
Address	229 Hickey Road
Flood Description	This site is in Black Street. Flood mark location coincides with flood extent as can be seen on the 1.20pm – 1.3.2012 aerial photograph. Owner/occupier of adjoining 229 Hickey Road has only lived there for 3 years so not able to comment.
Reliability	Medium
Flood Level (m AHD)	113.74
MGA Zone 55 Coordinate - easting	370345
MGA Zone 55 Coordinate - northing	5989824

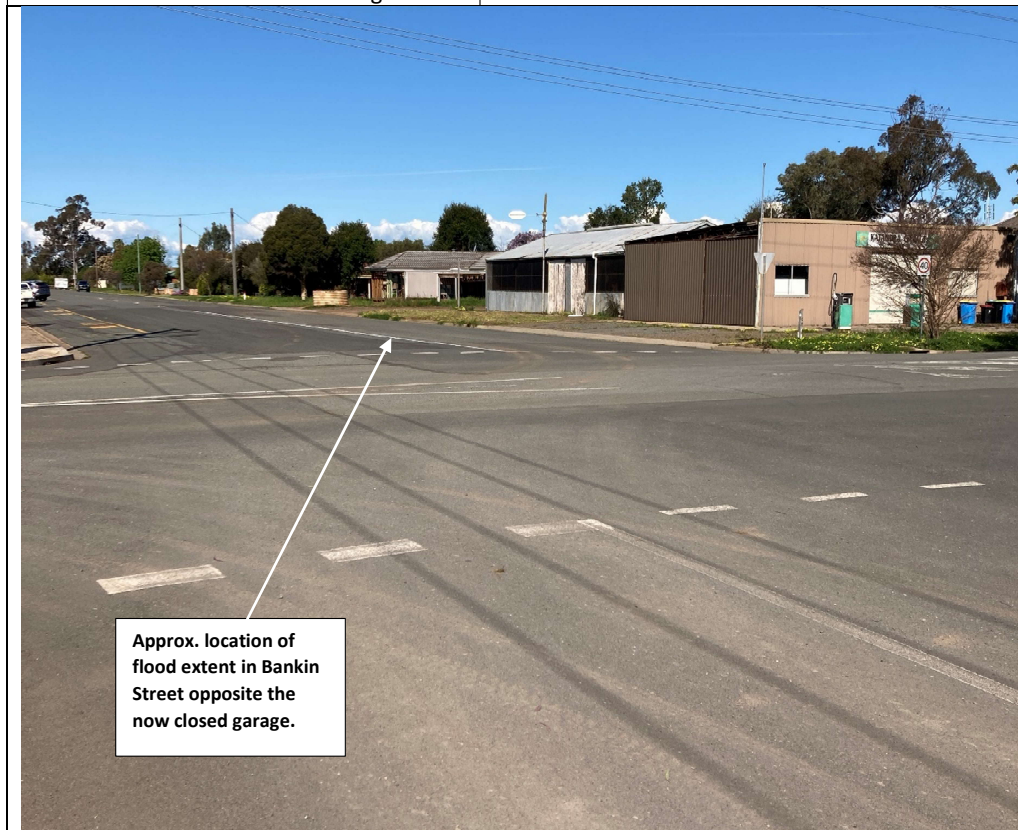
Flood Mark No.	FM2022- <b>KW4</b>
Date of interview / Inspection	29 September 2022
Name of Property Owner	-
Telephone	-
Address	10 Bankin Street
Flood Description	This site coincides with the flood extent edge as can be seen on the 1.20pm 1.3.2012 aerial photograph. Crown of road is above water line.
Reliability	Medium
Flood Level (m AHD)	114.07
MGA Zone 55 Coordinate - easting	370554
MGA Zone 55 Coordinate - northing	5990030

Approx. location of flood extent in Bankin Street opposite the now closed garage.

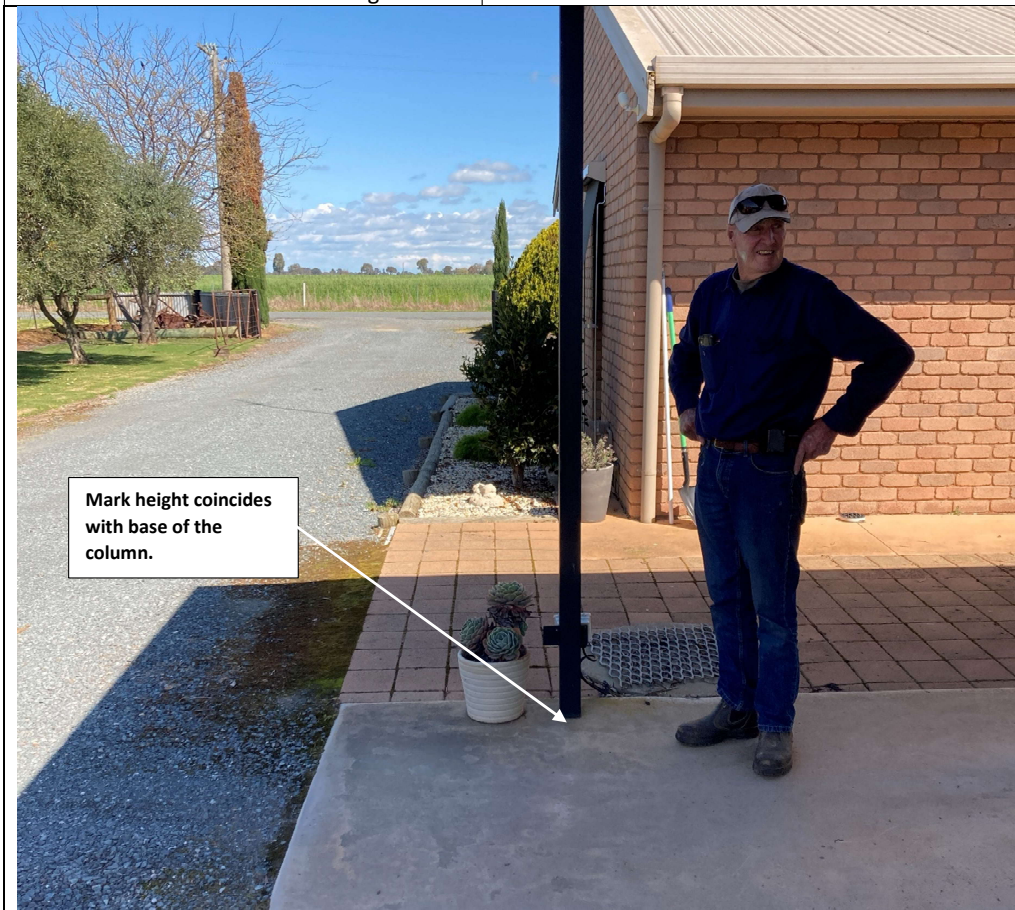
Flood Mark No.	FM 2022-KW5
Date of interview / Inspection	29 September 2022
Name of Property Owner	Steve Hickey
Telephone	-
Address	195 Hickey Road
Flood Description	Kevin Teague identified the site of this mark having spoken to Steve Hickey. Steve not at home at time. Steve later confirmed the mark location.
Reliability	Medium
Flood Level (m AHD)	113.24
MGA Zone 55 Coordinate - easting	369967
MGA Zone 55 Coordinate - northing	5989799

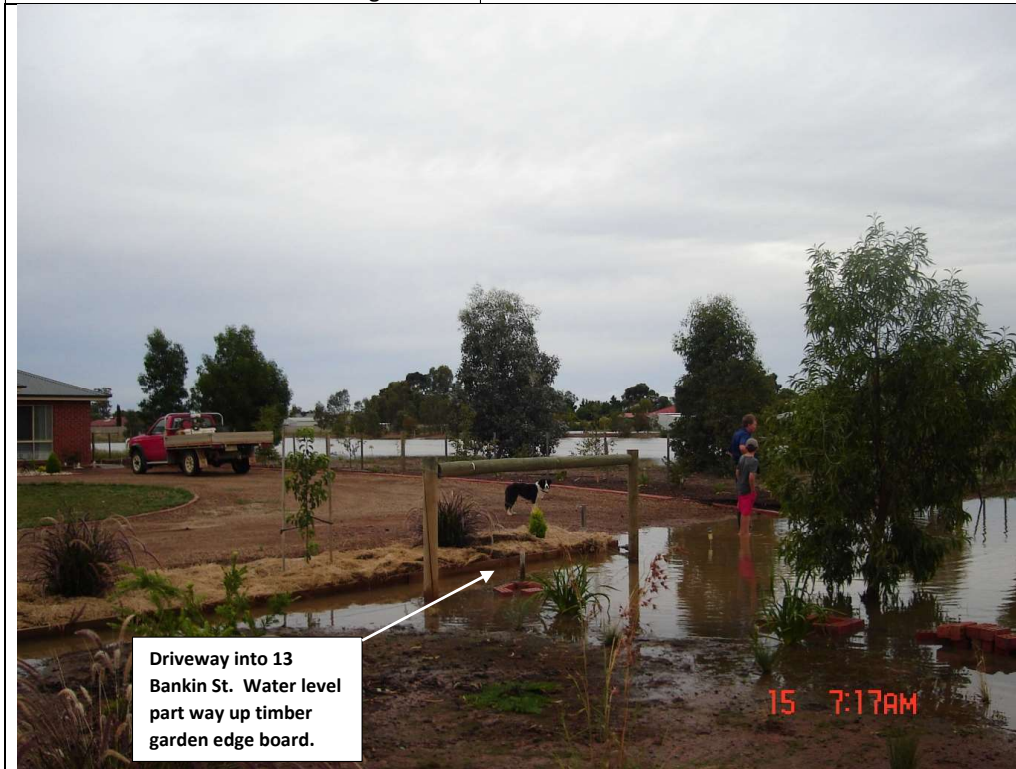
Flood Mark No.	FM2022-KW6
Date of interview / Inspection	6 October 2022
Name of Property Owner	Gary Sutherland
Telephone	-
Address	13 Bankin Street
Flood Description	This flood height mark coincides with the water level present on a photograph taken by Linda Wilkie (March 2012 flood). The water level is part way up a timber garden edge board on the left hand side of the driveway – see photo below.
Reliability	Medium
Flood Level (m AHD)	113.48
MGA Zone 55 Coordinate - easting	370305
MGA Zone 55 Coordinate - northing	5990042

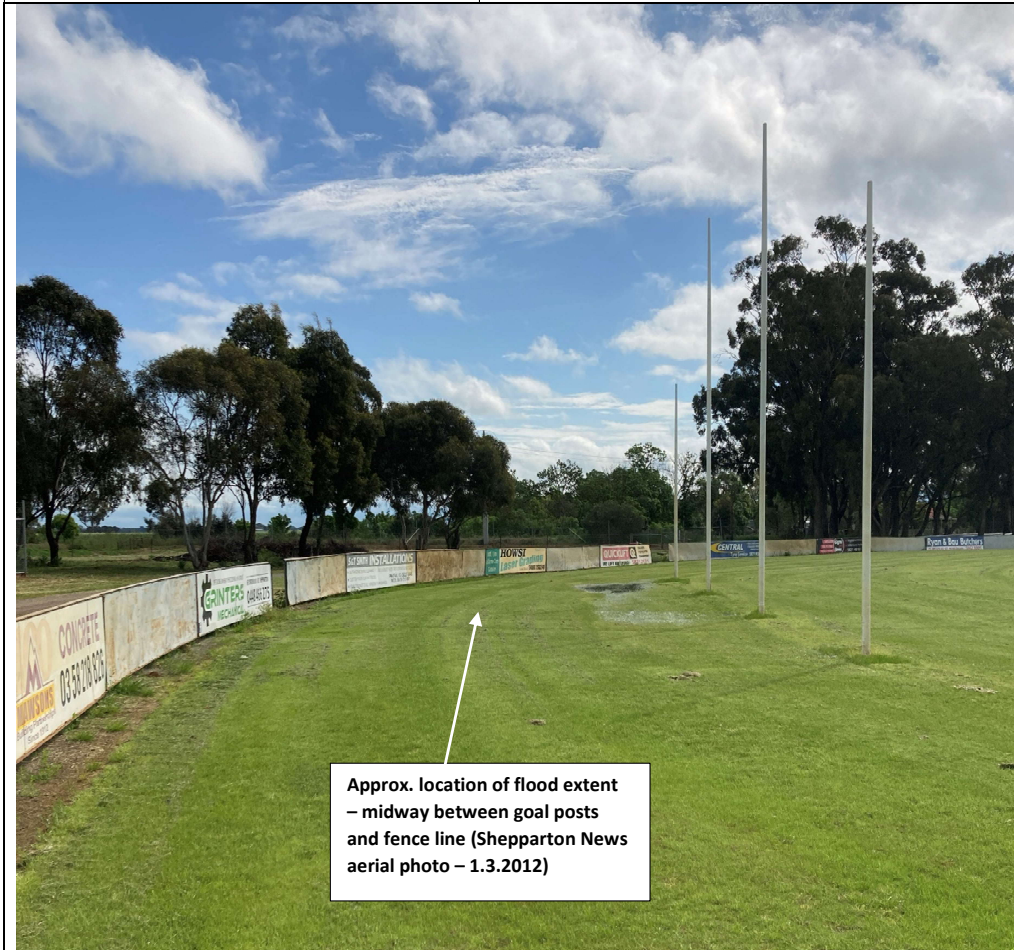
Flood Mark No.	FM2022-KW7
Date of interview / Inspection	6/10/2022
Name of Property Owner	- (Recreation Reserve)
Telephone	-
Address	-
Flood Description	Flood height mark location based on the Shepp News aerial photograph 1.20pm on 1/3/2022. Flood extent midway between goal posts and the oval fence.
Reliability	Medium
Flood Level (m AHD)	114.20
MGA Zone 55 Coordinate - easting	370619
MGA Zone 55 Coordinate - northing	5989604
