# Greater Shepparton City Council

## Katandra West Flood Scoping Study

### Final Report

May 2023

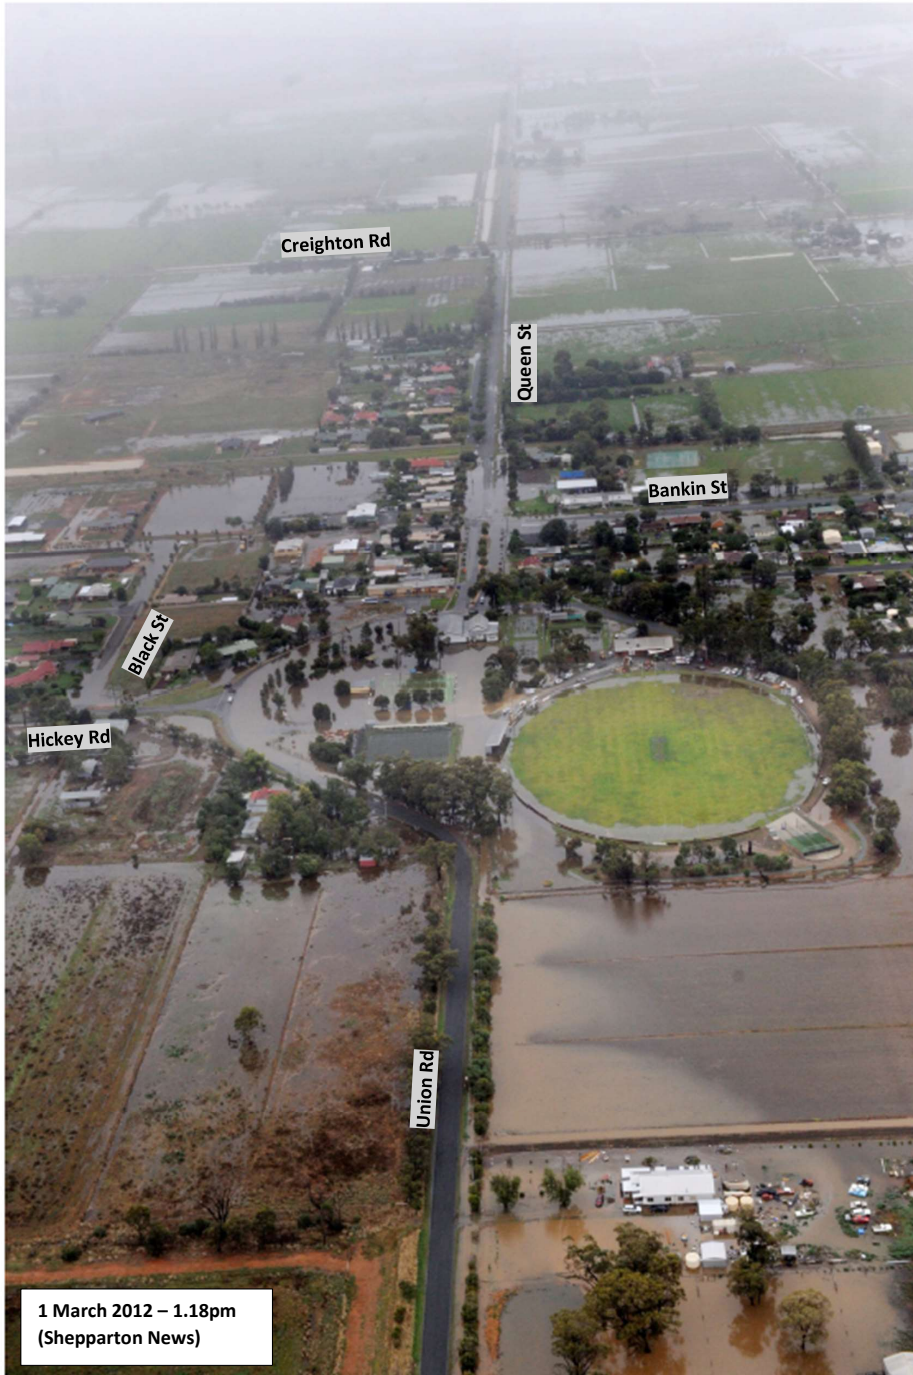
Figure 4 Aerial Photograph – March 2012 Flood

The SES also provided copies of aerial March 2012 flood photography originally obtained by Shepparton News. This includes the cover photograph of this report and the photograph shown in Figure 4.

An aerial photograph of the March 2012 flood (refer to Figure 4) shows this property to not be subject to inundation at the time the photograph was taken, which is thought to have been close to when peak flooding occurred.

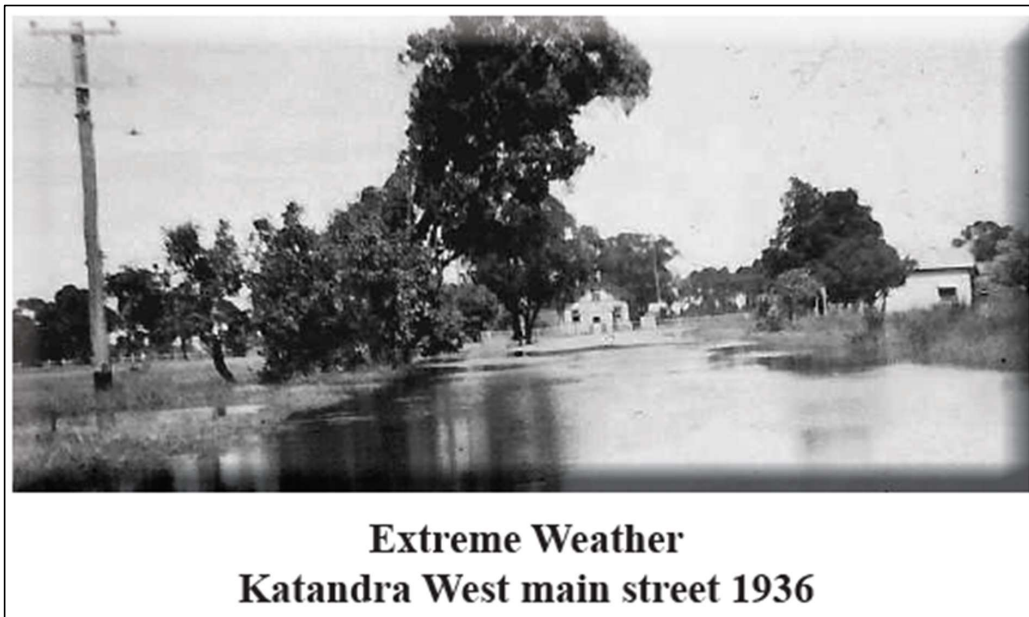
**Figure 5** Photograph Supplied by Katandra West History Group

The Katandra & District History Group was contacted. The History Group in response provide a copy of a photograph thought to have been taken in 1936 showing flooding of the main street at Katandra West (refer to Figure 5), which is the only flood related photograph or item held by the History Group.

The highest daily rainfall total recorded at the Katandra West station in 1936 was a relatively low 38 mm in late July. It is possible that the photography in Figure 5 relates to an event in October 1935 when 106 mm of rainfall was recorded at Katandra West.

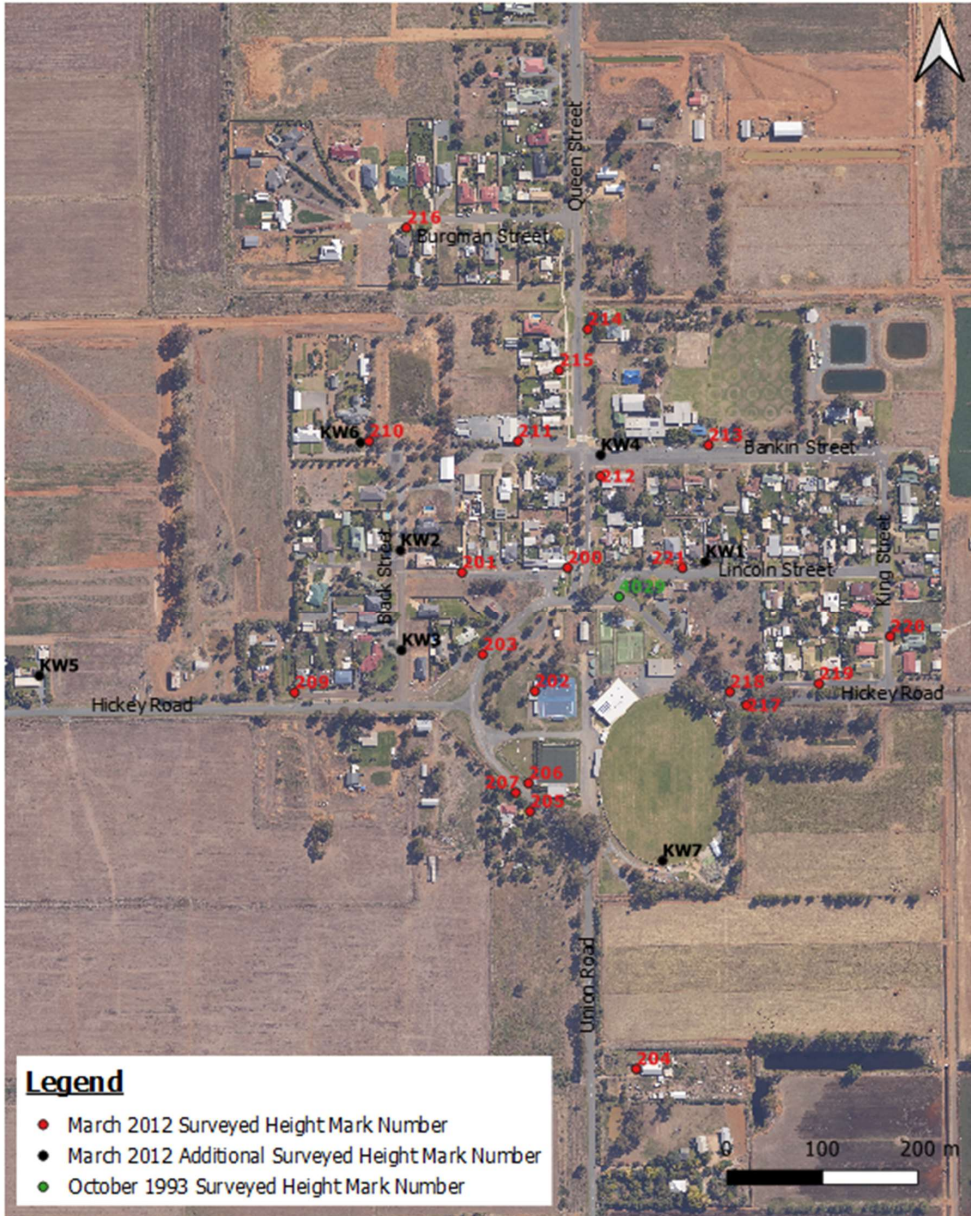
Figure 7 Surveyed Flood Height Marks

There is one 1993 spot flood height at Katandra West within the VFD (refer to Figure 7). Details are:

- Located at the intersection of Hickey Road and Lincoln Road (Mark 4029)
- Elevation 114.27 m AHD
- Assessed reliability – Low

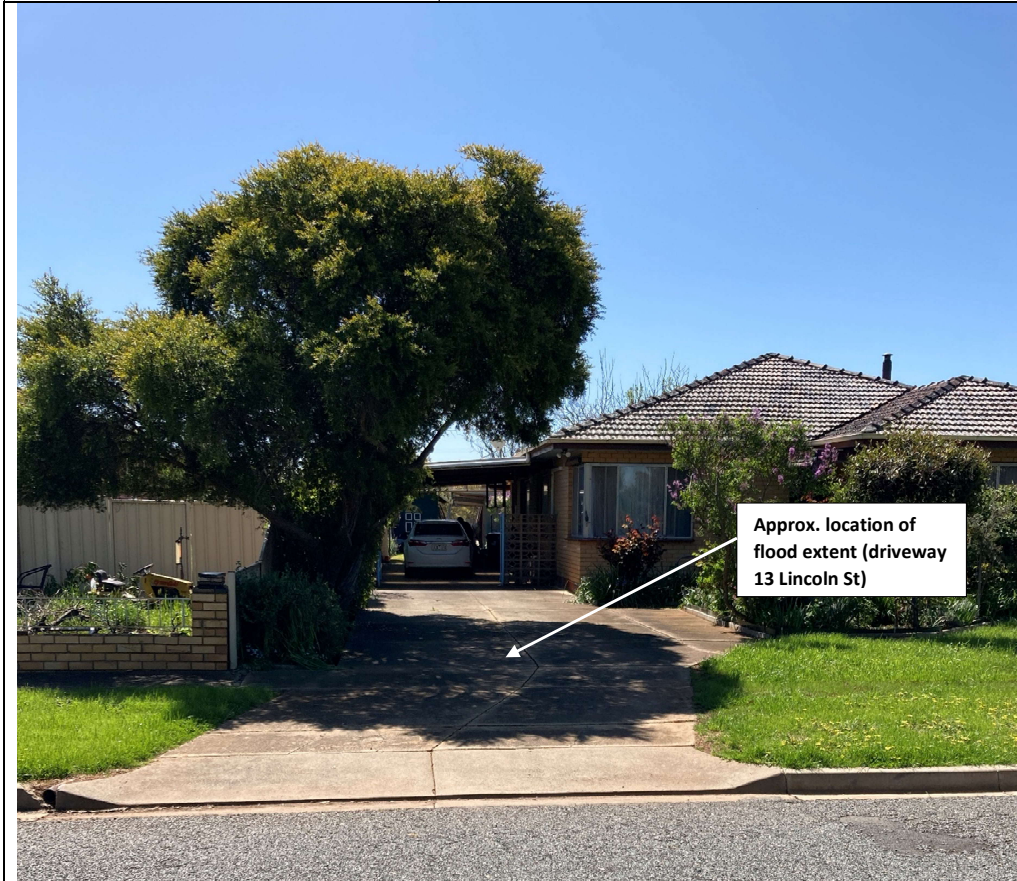
Flood Mark No.	FM2022-KW1
Date of interview / Inspection	29 September 2022
Name of Property Owner	Marjorie and Les Earl
Telephone	-
Address	13 Lincoln Street <a href="mailto:marjearl@bigpond.com">marjearl@bigpond.com</a>
Flood Description	Marjorie and Les Earl advised that floodwater did not encroach up their driveway beyond approximately their property boundary.
Reliability	Medium
Flood Level (m AHD)	114.23
MGA Zone 55 Coordinate - easting	370663
MGA Zone 55 Coordinate - northing	5989916

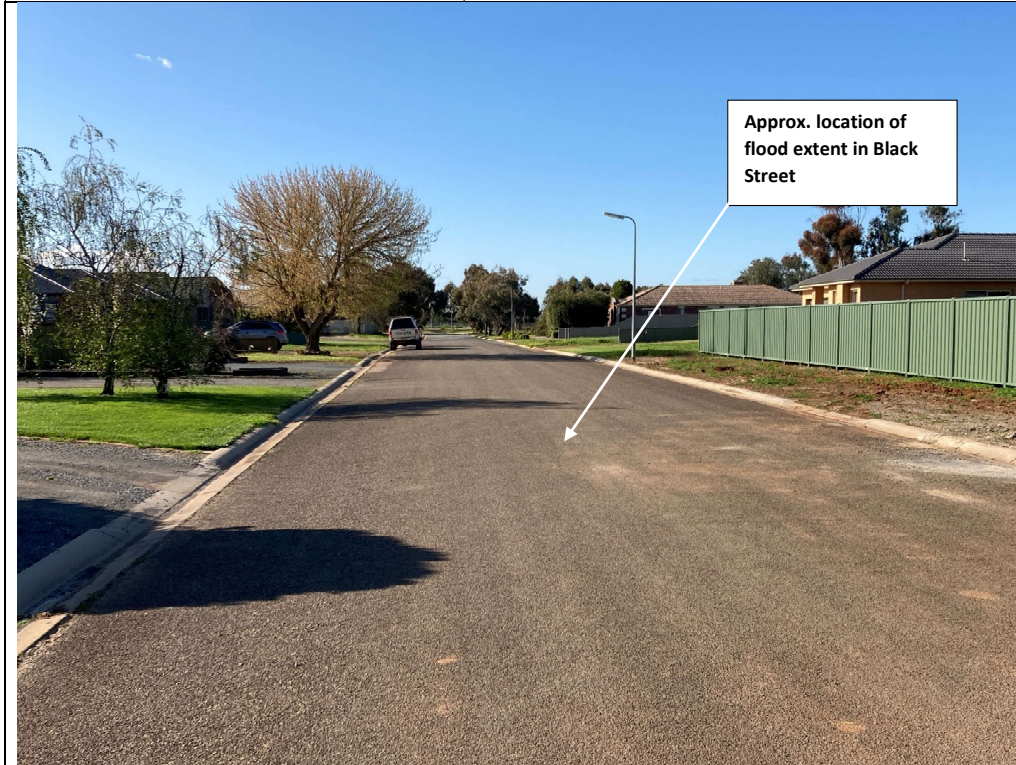
Flood Mark No.	FM 2022-KW3
Date of interview / Inspection	29 September 2022
Name of Property Owner	-
Telephone	-
Address	229 Hickey Road
Flood Description	This site is in Black Street. Flood mark location coincides with flood extent as can be seen on the 1.20pm – 1.3.2012 aerial photograph. Owner/occupier of adjoining 229 Hickey Road has only lived there for 3 years so not able to comment.
Reliability	Medium
Flood Level (m AHD)	113.74
MGA Zone 55 Coordinate - easting	370345
MGA Zone 55 Coordinate - northing	5989824

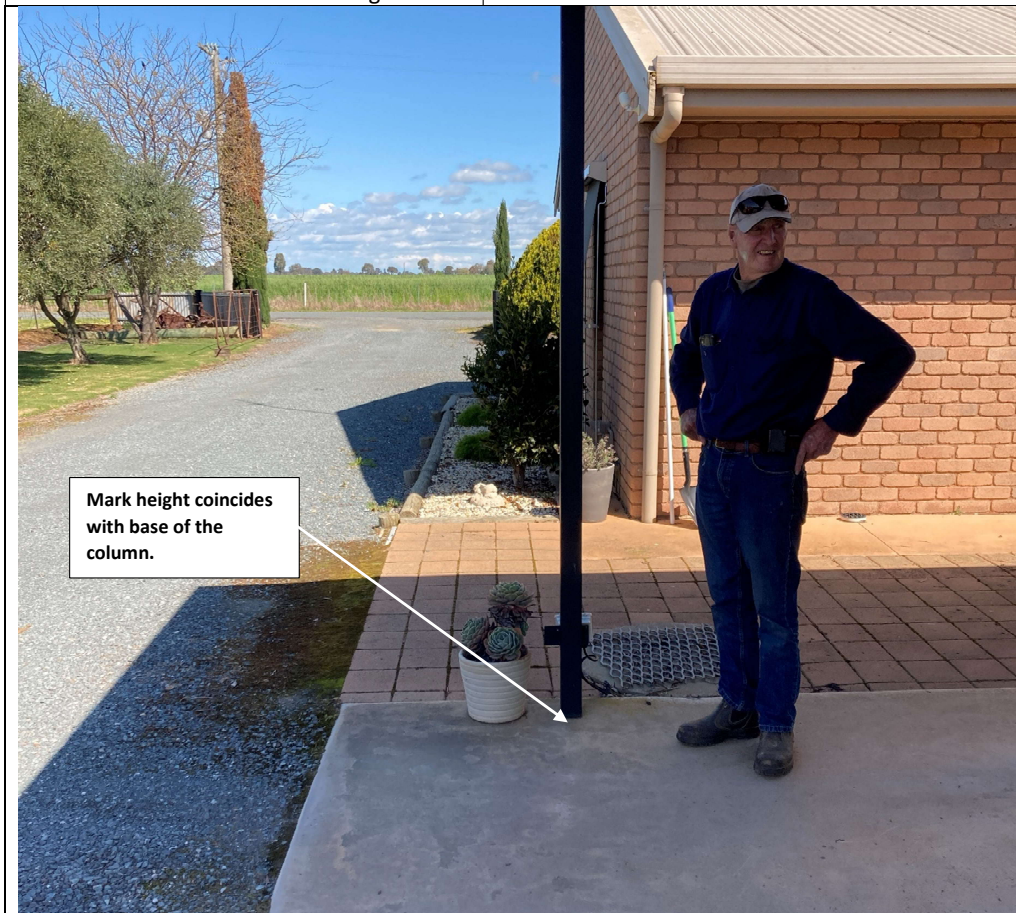
Flood Mark No.	FM 2022-KW5
Date of interview / Inspection	29 September 2022
Name of Property Owner	Steve Hickey
Telephone	-
Address	195 Hickey Road
Flood Description	Kevin Teague identified the site of this mark having spoken to Steve Hickey. Steve not at home at time. Steve later confirmed the mark location.
Reliability	Medium
Flood Level (m AHD)	113.24
MGA Zone 55 Coordinate - easting	369967
MGA Zone 55 Coordinate - northing	5989799

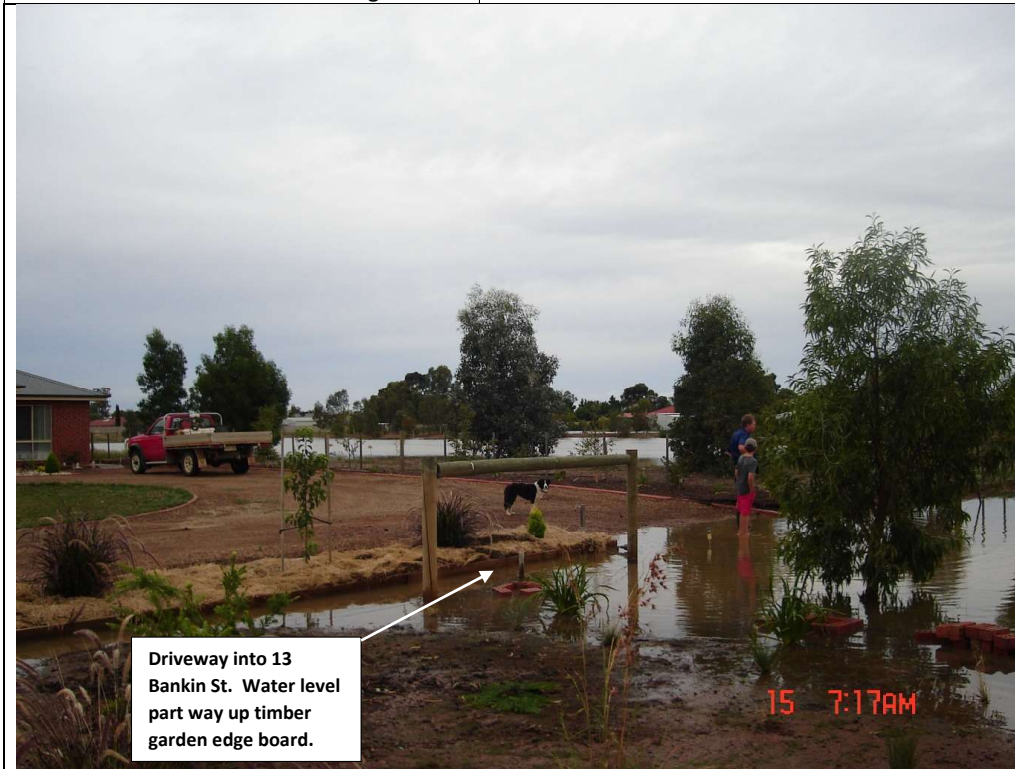
Flood Mark No.	FM2022-KW6
Date of interview / Inspection	6 October 2022
Name of Property Owner	Gary Sutherland
Telephone	-
Address	13 Bankin Street
Flood Description	This flood height mark coincides with the water level present on a photograph taken by Linda Wilkie (March 2012 flood). The water level is part way up a timber garden edge board on the left hand side of the driveway – see photo below.
Reliability	Medium
Flood Level (m AHD)	113.48
MGA Zone 55 Coordinate - easting	370305
MGA Zone 55 Coordinate - northing	5990042

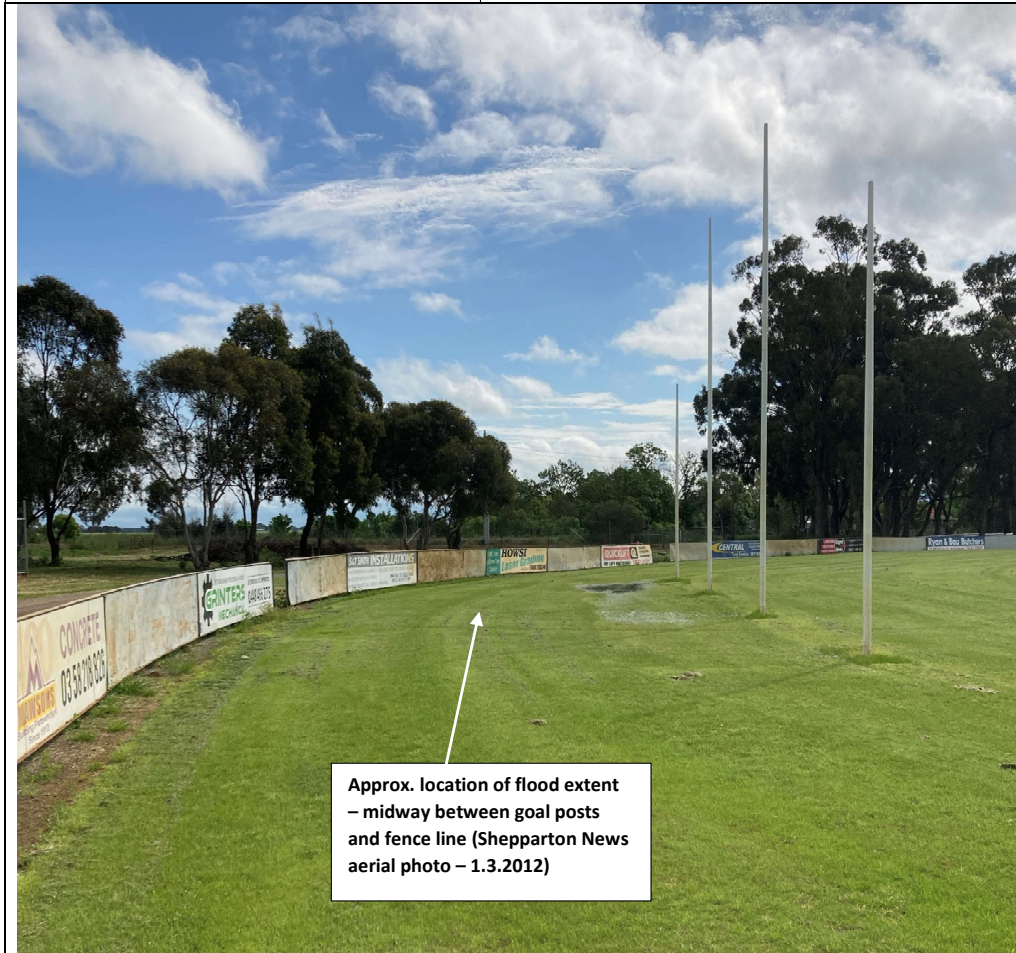
Flood Mark No.	FM2022-KW7
Date of interview / Inspection	6/10/2022
Name of Property Owner	- (Recreation Reserve)
Telephone	-
Address	-
Flood Description	Flood height mark location based on the Shepp News aerial photograph 1.20pm on 1/3/2022. Flood extent midway between goal posts and the oval fence.
Reliability	Medium
Flood Level (m AHD)	114.20
MGA Zone 55 Coordinate - easting	370619
MGA Zone 55 Coordinate - northing	5989604
